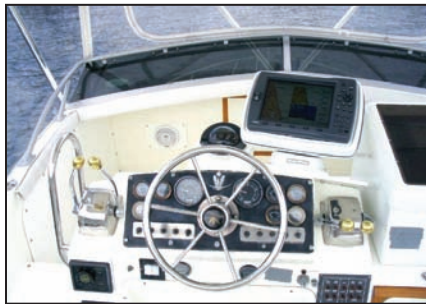
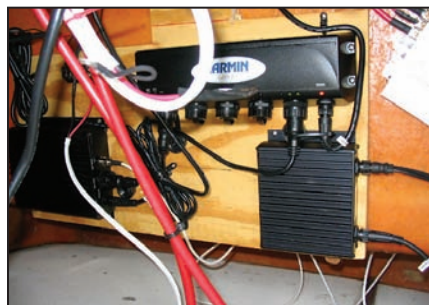
(top) Flying bridge with updated electronics. Chart plotter mounts on Navpod. (bottom) Network components mount underneath the bridge helm.

Upgrading the boat's outdated electronic equipment was our immediate interest. I settled on a Garmin chart plotter and big VGA color screen model 3010C and installed a depthsounder/fishfinder, satellite weather system and 36-mile (58 km) radar. I chose the integrated system because one screen shows everything, including the weather and radar, all on the same map with our position. The various network components were installed in the space under the bridge. The old and still functioning electronics are now our hard-wired backups. We also upgraded the stereo system on the boat. I installed a Clarion marine system, with separate switched amplifiers for the bridge and the cockpit speakers. That way we can have music on either or both and turn each on or off by a simple toggle switch at the helm.

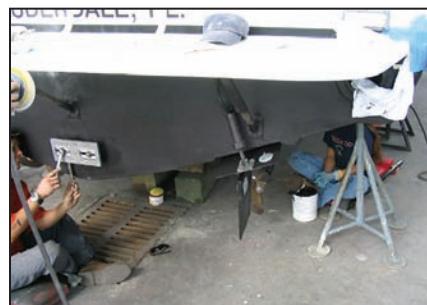
Plenty of helpers expedite the refit: over-size bonding plate is mounted on transom while hull receives new antifouling paint.

[Ed: For complete details on testing bonding systems also the what, why and where of anodes refer to DIY 2003-#2 issue.] The bonding system connects all below-water metal components together and to the sacrificial anodes. Most of the individual bonding conductor (wire) contacts to the ship's bonding system (to the two copper strips that run the length of the hull) were under the generator. After removing the generator and cleaning out the 18-years' worth of bilge sludge that lived underneath, it became clear that all the original bonding wires were probably not capable of doing their job and were making poor contact, if not broken loose completely at their terminal connections. Worse yet, only the rudders and shafts had been provided with zinc anodes but these were all wasted and not directly connected to the bonding system anyway. I knew that an investment in this system was key to protecting vital boat metal components, such as rudders, shafts, props, thru-hull fittings and valves, etc., from corrosion. Thus began the long process of completely reworking the ship's bonding system. I also installed new zincs on the shafts, rudders, swim platform struts, trim tabs, a big plate on the transom and connected them all to the bonding system. We settled on an 8kW Kohler generator. This was easily installed once the new bonding system was in place.

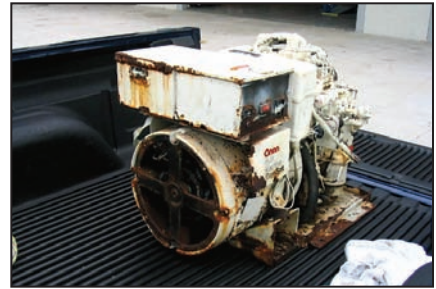
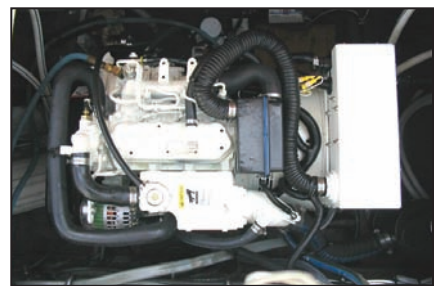
(top) Removing the old, rusty gen-set exposed an inadequate bonding system and resulted in a labor-intensive upgrade. (bottom) New 8kW Kohler fits the hold.

The original rusted 8kW Onan generator developed a fuel leak at the pump so it was another major project. Knowing that the generator was probably not reliable and that parts and service would be expensive, it just didn't seem worth fixing. Removing the generator led to one

of the most time-consuming upgrades that I've recently completed and one that no one will ever see or appreciate unless they have been through it themselves — the boat's bonding system.
